OVER THE CAMDEN, N. J. MAY 14, 1937. SOLDERING IRON

PREPARED FOR THE INFORMATION AND USE OF RCA VICTOR DISTRIBUTORS' SERVICE MANAGERS

SERVICE DIVISION

RCA MANUFACTURING COMPANY, INC.

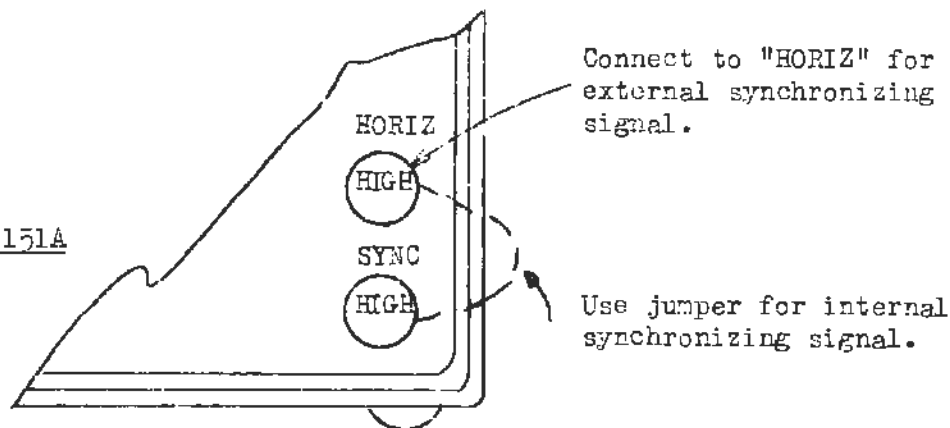
STOCK #151 & 151A
OSCILLOGRAPH

Unless proper connections are made at the "HORIZ-SYNC" terminals, it will be impossible to lock-in the synchronizing signal or to control it correctly. The terminal marked "HORIZ" is the input to the horizontal amplifier and the "SYNC" terminal is used for connection

purposes only in order to employ internal synchronization. When external synchronization is to be used, attach the source of the signal to "HORIZ" and "O" terminals of the oscillograph, and turn the Amp.-H switch to "Timing". For internal synchronization, a jumper lead such as shown above, should be connected between "HORIZ" and "SYNC", and the Amp.-H switch placed in the "Timing" position.

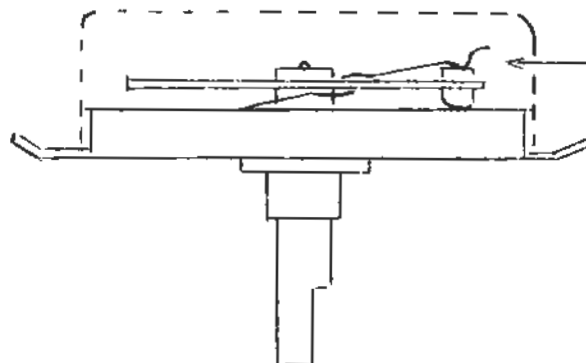
Many controls of the Stock #11237, #11205 and #5223 types have a construction as shown by the sketch below. Any noise developing on these units can be satisfactorily eliminated by cleaning the contact

Contact point between spring and shoe must be cleaned.

point between the phosphor bronze spring of the wiper arm and the monel metal sliding shoe. The cleaning should be done by drawing a strip of crocus cloth or very fine sandpaper through the contact so as to clean both parts. A small amount of very light oil or Vaseline applied to the contact surfaces after cleaning will prevent future corrosion.
