# OVER THE SOLDERING IRON

RCA VICTOR

PREPARED FOR THE INFORMATION OF RCA  
VICTOR DISTRIBUTORS' SERVICE MANAGERS

SERVICE DIVISION - RCA MANUFACTURING COMPANY, INC. - CAMDEN, N. J. - FEBRUARY 24, 1938

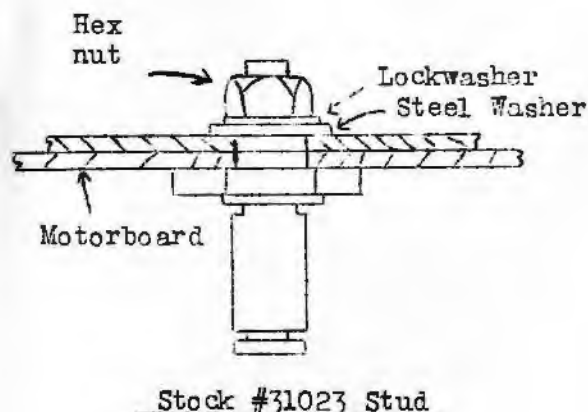
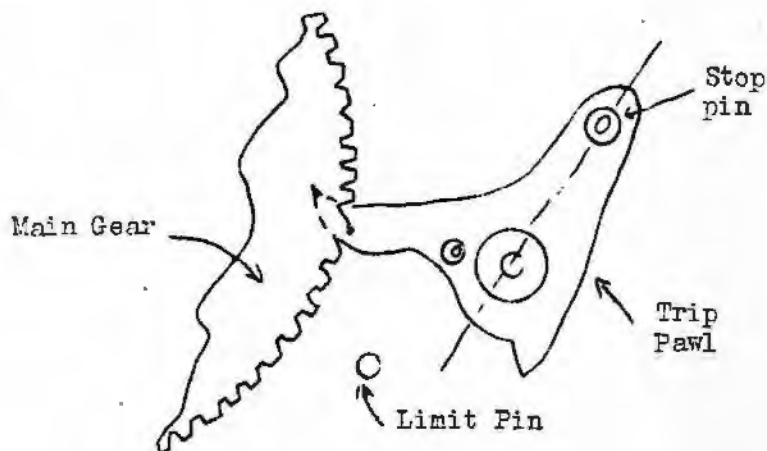
REPLACEMENT MOUNTING STUD STOCK #31023For Automatic Record Changer Cam and Gear Assembly

Stock #31023 cam and gear mounting stud is being made available for service replacement use on the large automatic record changer mechanisms such as are employed on Models 331, 341, 381, M1-2, D22-1, 9U, 9U2, 15-U, U-106, U-107, U-108, U-109, etc. The stud, illustrated below, will facilitate and simplify repairs necessary where the original part has become loosened in its mounting; due to the fact that it is mountable by means of a nut and washer.

- (1) Remove entire motor assembly from the motor board.
- (2) Remove cam and gear from stud.
- (3) Extract original stud from board, using pin punch.
- (4) Straighten motor board being sure it is normally flat in vicinity of stud mounting hole.

- (5) Install new stud with nut and washers provided. It must be perfectly square or perpendicular to the motor board.
- (6) Re-install cam and gear. Revolve the gear so as to carry mechanism thru a change cycle several times and note the engagement of roller on main link and the cam of the main gear. Bend the trip pawl stop pin toward or away from the lever so as to vary the roller engagement as required. The bend should be in the direction of the center line between pawl mounting stud and stop pin. The roller must be prevented from striking the edge or inside of the cam and causing a bind.

- (7) If pin which limits movement of the trip pawl is sheared off from the motor board - replace it with a standard 8-32 screw, using locknuts to secure it to the board.

- (8) Replace motor and adjust its position to give a free-running mesh between the pinion and the automatic main gear.
- (9) Cover the main gear and cam with light grease such as "Socony-Vacuum No. 2".
