OVER THE SOLDERING IRON

RCA VICTOR

PREPARED FOR THE INFORMATION OF RCA
VICTOR DISTRIBUTORS' SERVICE MANAGERS

SERVICE DIVISION - RCA MANUFACTURING COMPANY INC. - CAMDEN, N.J. MARCH 17, 1939.

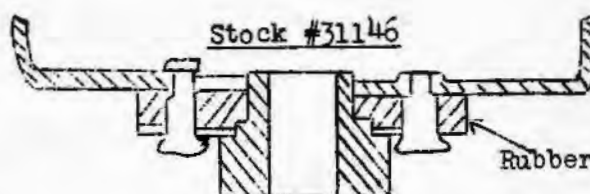
TURNTABLE FLUTTER OR WOW Models U125, U128, U130, Etc.

It has been found possible to prevent any flutter or ripple wow that may possibly be experienced on these Victrolas by use of a specially designed motor coupling assembly. This assembly has an auxiliary flexible rubber coupling, as illustrated above, which mechanically filters the higher frequency speed variations. The Unit is covered by Stock #31146. It can be used to remove "flutter" or "ripple" which is reproduced as wow or speed variations occurring several times (4-8) per turntable revolution. Its effect on the more common type of "once-around" wow is not appreciable. When installing motor using this coupling, first assemble motor support in cabinet with motor screws loose. Move motor around until the hub of coupling #31146 can be pushed up around turntable spindle sleeve as a centering pilot. Tighten motor mounting screws securely. Lower coupling #31146 on motor shaft to normal position and tighten set screws.

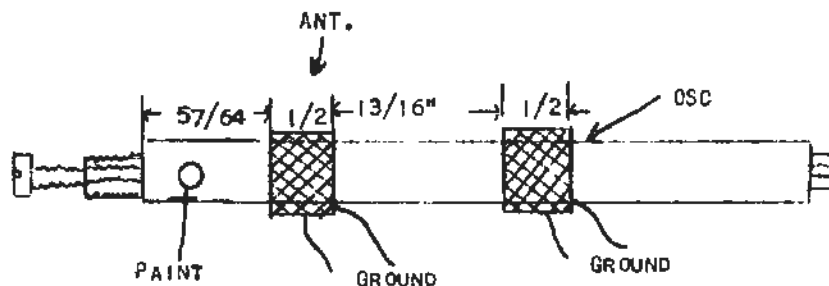
When servicing these receivers, do not shift the positions of either the oscillator section (front) or antenna section (rear) on any of the four tandem push button coil assemblies, since their positions on the form governs the tracking between the two circuits. The illustrations below show the proper spacings of coils. If necessary, seal the coils securely to the form with wax to the dimensions shown.

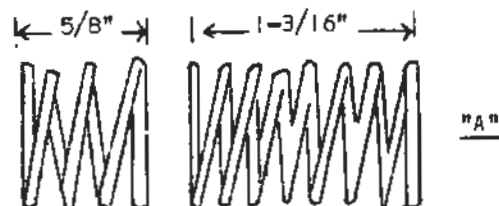
Records containing heavy bass response in the region from 50 to 80 cycles may be subject to damage from groove or wall breakdown as a result of mechanical-acoustic feedback into the pickup unit. Subsequent playing of records so damaged results in abnormal distortion during the low frequency passages. This condition can be rectified by removing or displacing the mechanical and electrical resonances, and the undesired mechanical coupling that contribute either singly, are which may be accumulative. The following operations should be carried out to effect the necessary remedy:-

Spring combination "A" corresponding to dimensions shown should be installed on each of two motor mounting studs supporting field coil assembly of motor (nearest rear of cabinet) with $5/8$ " spring above motor board and $1\ 3/16$ " spring below.

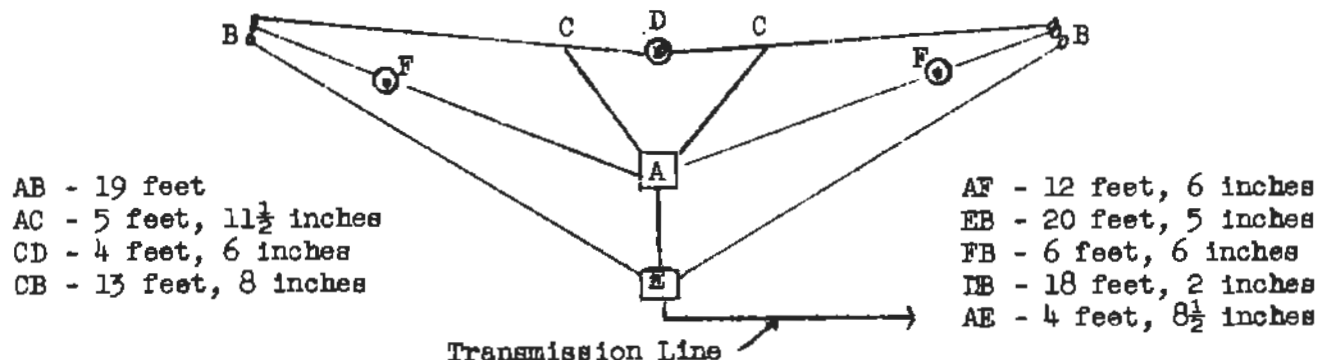
SPIDER WEB ANTENNA - Dimensions

The following information giving correct dimensions of the Spider Web Antenna will enable an accurate check and correction where difficulty is encountered in obtaining the proper suspension. Measurements are given from end loops of leads to centers of holes in insulators.
