AUDIO ALIGNMENT PROCEDURE

VOL. 1, NO. 1

TC CHASSIS -- POWER SUPPLY PRE-REGULATOR TRANSISTOR (Q21) FAILURE

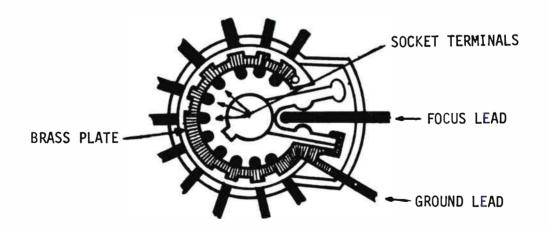
REAR VIEW OF SOCKET (COVER REMOVED)

The picture tube socket used in the G-l Chassis color receiver contains a special built-in spark gap consisting of a grounded brass plate placed close to the socket terminals (see sketch below). An unusually high voltage on a socket terminal will arc to the brass plate rather than to an adjacent terminal, thus protecting the picture tube and its associated components. This is normal, and does not necessarily mean the socket is defective, but usually indicates a problem in associated circuitry.

For example, we have had cases of a continuous arcing condition in the CRT socket caused by an open 47 Meg. resistor (R284) in the focus voltage divider circuit. To obtain best focus, this resistor is connected through a wire jumper to one of three points — B+ boost, +280V, or chassis ground. A bad solder connection at the jumper or an open R284 could cause the voltage on the focus anode terminal (Pin 9) to rise, causing an arc inside the CRT socket.

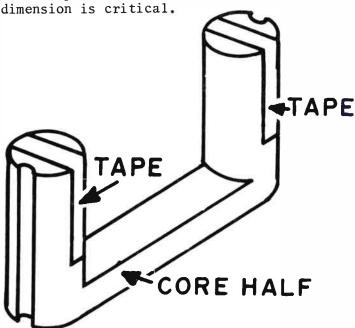
The air gap is controlled by special paper tape between the core halves. Originally, one thickness of tape was used to create this air gap. Now, two thicknesses of tape are used to create a 15 mil gap. The proper tape is Scotch Brand No. 280, which is available from your General Electric Parts Distributor under Catalog Number EP60X9.

To modify an early production receiver, dismantle the HVT and remove the original air gap tape from the core halves. There may be some versions with black plastic electrical tape used as pads between the core and high Voltage Cage. Remove these pieces of tape also. Use four pieces of new tape approximately 1 1/2 inches long. Attach tape to both ends of both core halves as shown in the drawing. Be careful that the tape does not wrinkle or have foreign material stuck to it, as this air gap dimension is critical.

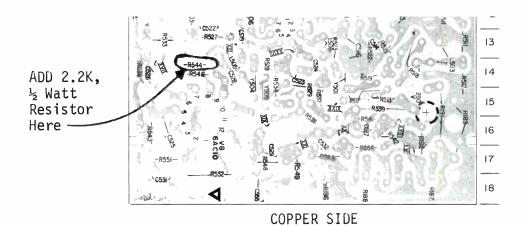
BOARD NO. 4--VIDEO-AUDIO-CHROMA CIRCUIT BOARD

A change has been incorporated in late production C-1 chassis receivers to reduce chroma noise in weak signal locations. The value of the matrix resistor, 4R544, has been changed from 2.7K to 1.2K to improve the signal to noise ratio in the G-Y color difference amplifier. If needed, this improvement can be incorporated in early production receivers by paralleling the 2.7K resistor with a 2.2K, 1/2 watt resistor. The 2.2K resistor can be placed on the bottom of the circuit board. (See Illustration).
