THE COLLINS
GUIDEBOOK
AND
NOTES

PUBLISHED BY
THE COLLINS JOURNAL
Sidman, PA 15955
1994

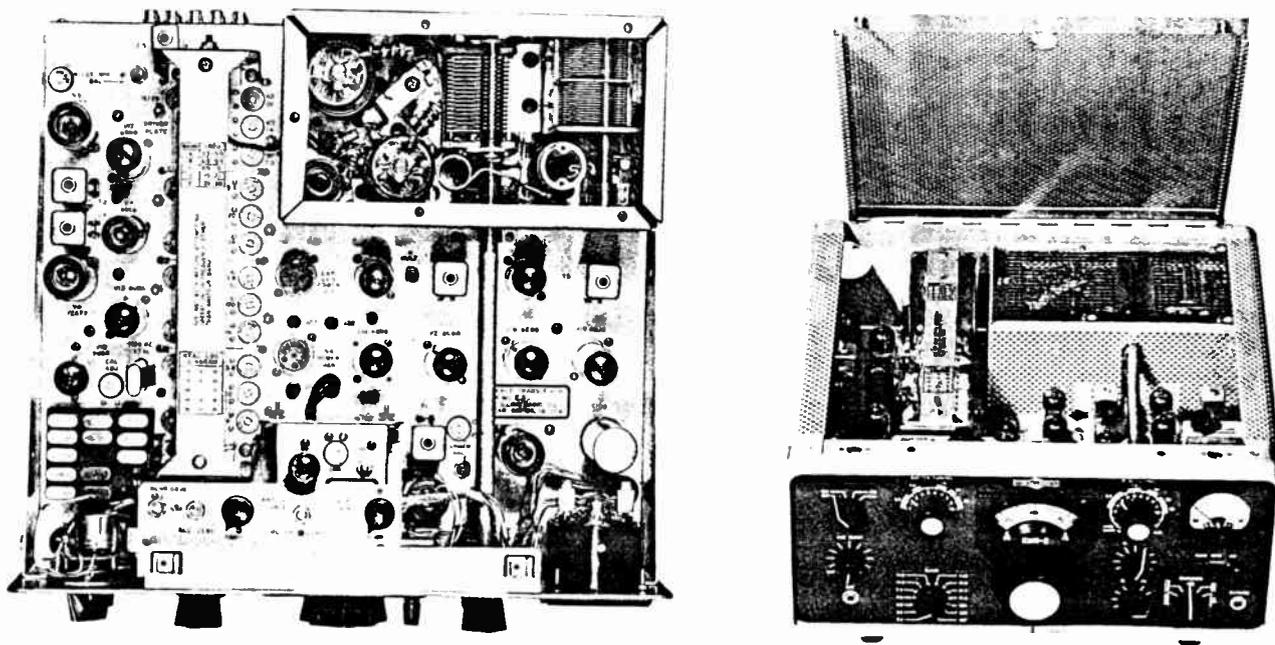
Top View of KWM-2 Transceiver

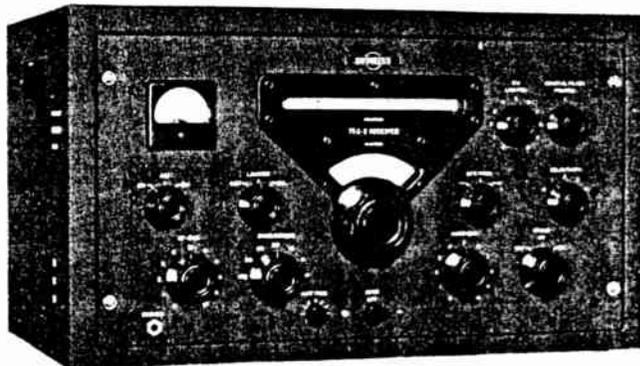
COLLINS VERNIER TUNING KNOB

The popular vernier tuning knob that was specifically designed for the Collins 75A4 receiver became retrofitted to other Collins sets such as the KWS-1, 32V series transmitters, 51J series, KW-1, 310B series and earlier 75A series receivers. The construction is such that it can be readily taken apart for cleaning and lubricating. The following information was excerpted from the official Collins instruction booklet on the knob.

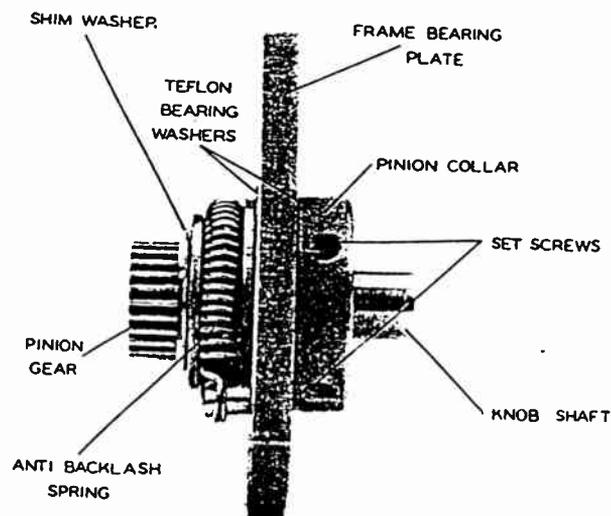
Lubrication: If at any time, the knob loses its smoothness or begins to feel toothy, there is a possibility that the lubricant has become dirty or dried out. Remove the entire assembly from the receiver and wash the vernier mechanism in cleaning solvent - kerosene will do nicely with a toothbrush. Clean out the back of the tuning knob with a clean lintless cloth. Coat the ring gear teeth with a thin film of light grease such as Lubriplate or Vaseline. Disassemble the pinion from the pinion collar by releasing the two collar setscrews and withdrawing the pinion shaft. Wash the parts in solvent and then reassemble after first coating them with the light grease. Squeeze the pinion and the pinion collar together and tighten the setscrews. Assemble the remainder of the knob.

Adjustment: If the tuning knob feels wobbly, remove the knob, release the pinion collar setscrews (see figure) and squeeze the pinion and pinion collar together, then tighten the setscrews and replace the knob. If the tuning knob binds as it is rotated, remove the knob, release the pinion collar setscrews (see figure) and loosen the pinion and pinion collar. Tighten the setscrews and replace the knob. Continue adjusting the pinion and pinion collar until the knob turns freely with a minimum of wobble. The main dial should not move when the BFO control is rotated. If it does, tighten the pinion and pinion collar as described above.

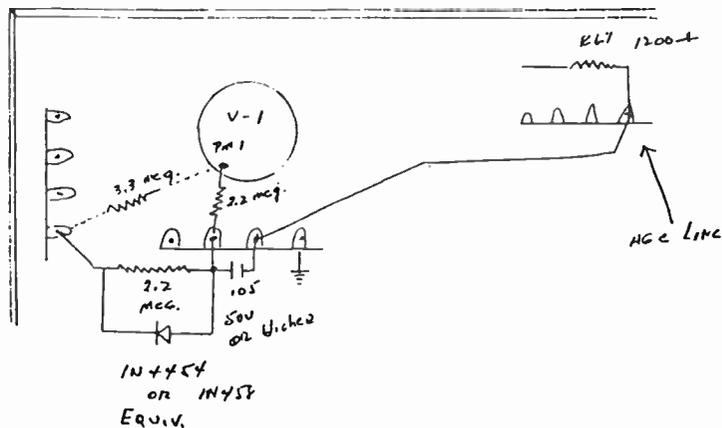
75S-3 AGC Change

Mount a 4 terminal strip (with 1 terminal grounded) under socket screw of V-2. Replace a 3.3 Meg. resistor with (2) 2.2 Meg. 1/2 watt resistors as per illustration. By using a four terminal strip, it allows room for the components used in modifying the 100 KC calibrator circuit. This produces a harmonic generator and levels out the 100 KC markers between 80 and 10 meters. (Note: this 100 KC modification can be lifted from the 75S3B,C schematic)
