VOL 52
WINTER
2023

The
Indiana
Historical
Radio Society
BULLETIN

RESTORATION *Corner*

The "Off the Grid" Portable Workstation

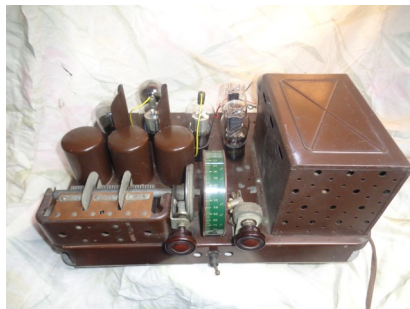
When I got it home and I looked it over, I found the chassis to be rust free. I cleaned everything and the original brown paint looked great.

The bottom of the chassis had a metal plate screwed to it and was corrosion free. Only four screws held it in place and I found the chassis underside to be remarkably clean. I did see one paper capacitor had been chewed on and it tested as shorted. Another paper capacitor was found to be not just leaky, but down right shorted and it was in the B+ supplying the screen grids. The filter capacitors checked good and that didn't surprise me. The filters in a lot of early AC radios held up rather well. I found this to be true of Radiola 17's and 18's. There was a metal box with three bad capacitors inside, so I dug out the tar and placed new capacitors inside the box. This kept the chassis looking original and neat.

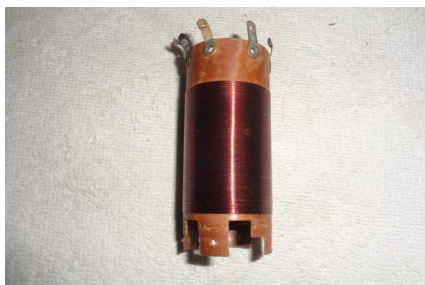
I made a roadmap showing where all the wires went to the coils and I only did one coil at a time. After removing the 1st RF coil, I found the wire going from the top of the coil down to the bottom terminal was missing.

This would have been a wire that originally ran down the inside of the coil. I found this odd and I figured it had to be the result of a varmint of some kind--a mouse readily came to mind. I've seen lots of roach, mouse and rodent damage over the decades. They will cut a wire in half but they don't eat the whole wire. As mentioned earlier, the underneath of the chassis was clean and there weren't any bits and pieces of wire or anything else. Whatever it was ate the entire wire--at least it didn't eat the coil. I added a replacement wire, reassembled the coil. Plate voltage appeared on the first RF tube. Whatever ate that wire either must have been really hungry or wanted some unusual roughage. I bet its poop was conductive.

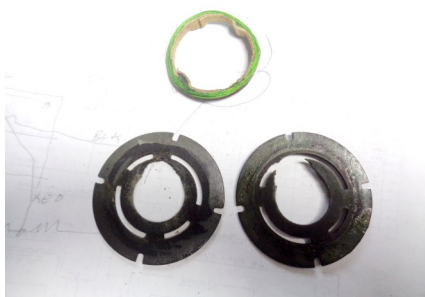
The 2nd RF stage also didn't have any plate voltage, so I had to remove that coil as well. Not only did the critter eat the wire inside the coil form, but went to the top of the coil and munched on the form. The primary winding was destroyed.

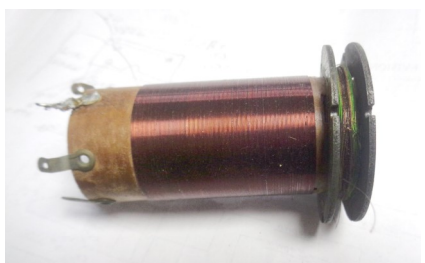
The wire for the primary was discarded and re-wound with wire of the same size. I also wound it in the same direction as the original. This is very important; winding coils in the opposite direction will reduce the output of the transformer. After installing the repaired RF coil, not only was there plate voltage on the second RF stage, but a weak signal appeared--progress!

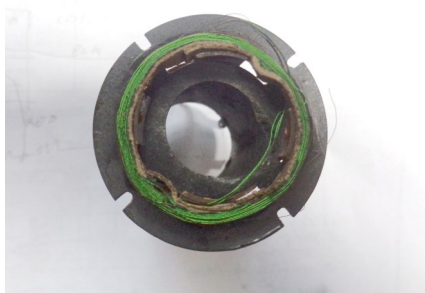
The weak signal was due to the antenna input transformer. Upon inspection--you guessed it--the wire inside the coil form

was completely gone as was in the other two RF transformers. That coil was removed, the missing wire was replaced. Stations were now coming in loud and clear.

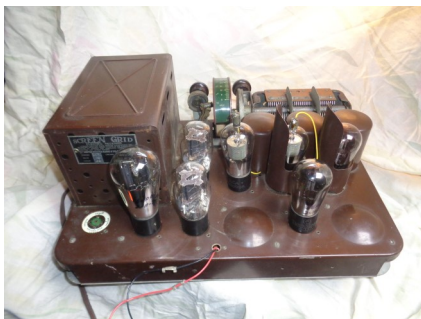
The pot metal variable capacitor reminded me of other radios from that time period. Those capacitors were so warped it rendered the radio inoperative. I came up with a way that can make a radio like that useful. I set the variable capacitor to minimum capacitance, high end of the dial, where the capacitor plates weren't shorting out and placed a newer matching variable capacitor, in my case a three section variable capacitor, and placed it in parallel with the bad

capacitor. It worked! I aligned the trimmer capacitors on the new variable capacitor at a station around 1400kHz for maximum volume. After that I could tune in the broadcast band and pick up lots of stations. Of course, the radio has to be tuned from inside the cabinet. Many people only listen to one station, so at least the radio is useable. Coming up with a perfect, original pot metal variable is difficult. Engineering a newer capacitor onto the chassis is even more difficult, so this is an easy way out.

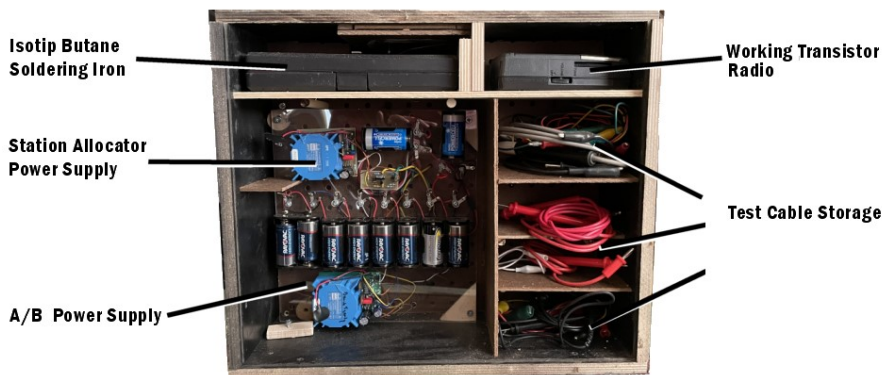
REAR VIEW

The front section contains the following:

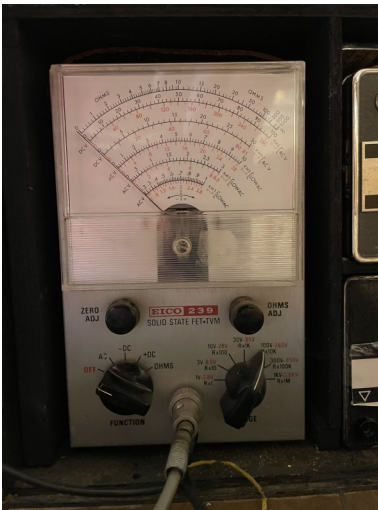
An Eico Model 239 FET-VM. Uses three nine-volt batteries and a D cell.

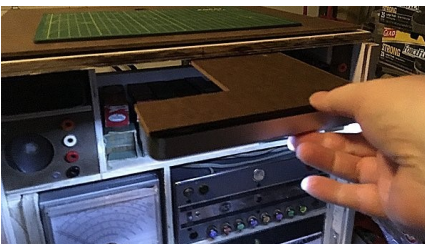
An overhead LED light I picked up at a hardware store. Uses two AAA batteries. I designed it to where it slides out when you're ready to work, slides back in for storage. I might be replacing it when I can find something a bit brighter.

Test Antenna—this is a loop antenna from an RCA BP-10 Personal radio. It's mounted above the LED light. Its leads are routed to a panel in the front.

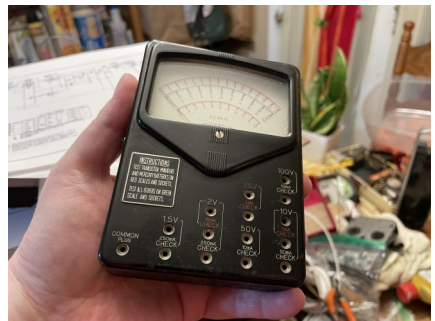
Battery tester—a small pocket unit made for Canadian Eveready. Voltages are available on its front panel. You just plug the leads into the appropriate socket.

Signal Tracer—a small Radio Shack pocket model. Allows for tracing audio and RF circuits.

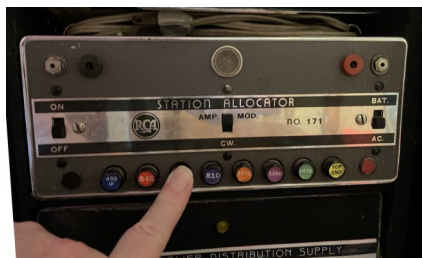
Signal Generator—a prewar RCA Model 171 Station Allocator. Its purpose was to aid the serviceman with pushbutton adjustments on console radios. It was made during the FCC's AM station reallocation around 1940. They designed case around an elongated BP-10 personal radio cabinet. On the front are eight pushbuttons, each set to a desired frequency. The first one I aligned to 455 khz for IF frequencies, the rest are stations on the AM band, allowing quick access to them during alignment. The unit can be operated by battery or AC. In this case, it's powered by two C cells for filaments and its own regulated power supply for the B voltages.

A/B Power Supply—this is a homebrew panel and uses the shell of an RCA BP-10. I designed it to match the station allocator's layout. A small yellow LED lets you know it's on. Below the LED are jacks for all filament voltages from 1.5 to 12 volts and B voltages ranging from 22.5 to 90 volts. The filament voltages are fed from a bank of six C cells tapped at their respective voltages.

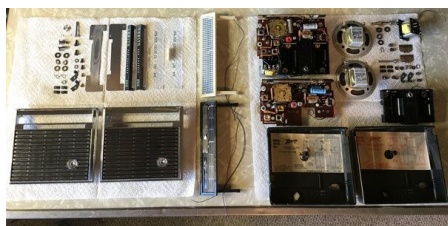
I recently refurbished two early Admiral sets for a collector friend. I asked if he had a Zenith Royal 555 Suncharger parts set. I needed a repairable black handle which was missing on one of my sets. He sent two sets; one had a complete and working white handle, a badly hacked chassis and broken black cabinet. The other had a complete and repairable chassis, a solid black handle missing its lens along with a few of its solar cells. Kinda funny since my first "pair" of 555's refurbished years ago included what was once a white set with black back cover and a complete black set---and I had bought a discolored white back cover from him to "originalize" the white one...

After close examination, thought I could make two complete working sets by combining the best parts of these two with my working "handle-less" set. After completely disassembling and detail cleaning both, I saw that the chrome front panels were much better than my incomplete unit, so I also disassembled it for the "project". One of the emblems was missing from the dial-light button and the other was dented and loose. I removed the one and very carefully worked out the tiny dents by placing a small piece of

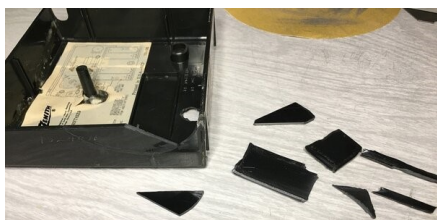
The hacked unit also had a broken and sloppily glued black cabinet back, so I decided to attempt "bodywork" and then paint

it antique white to match the handle. A chunk of plastic was missing, so after sanding the edges smooth around the opening and making a pattern, I carefully cut a replacement piece slightly oversized from a junked black Panasonic cabinet. Then I sanded its edges little by little until I had a good fit. I superglued this new piece into place while holding the side of the cabinet tightly against a piece of release paper on the table to ensure that outside surface would be flush with original. After the glue set, I carefully scraped and shaved the excess from it with a utility knife blade in

preparation for sanding and painting. The new plastic piece turned out fine---but while scraping off excess glue from previous repairs, a very small chunk of the bottom corner broke off---and got sucked up accidentally into the vacuum cleaner ! So I carefully poked around in the most recently layer of debris and thankfully I found it. After carefully filing the tip edge of the new patch piece, I glued it into place. Had some tiny gaps at the glue line, so I got out my automotive spot putty to fill---and it had separated due to age. Squeezed enough out of tube to mix, and applied carefully.
