Pf Reporter®

the magazine of electronic servicing

Color Tv Service Training

CHROMA CIRCUITS

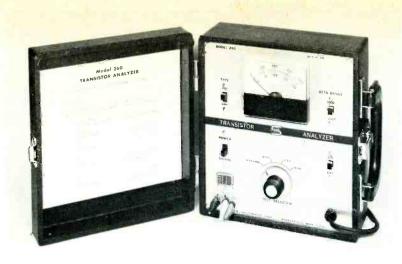
Fig. 3. New transistor tester has no Beta Cal control.
