# ELECTRONIC SERVICING

APRIL  
1958 • 50¢

SILICON RECTIFIERS FOR TV AND RADIO

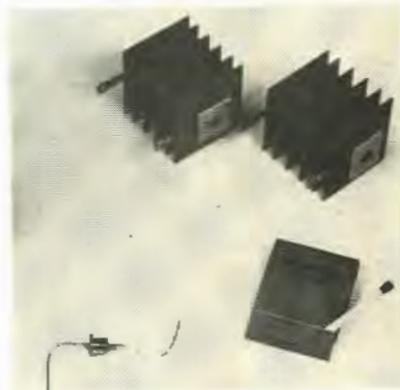
The size comparison between selenium rectifiers and a silicon rectifier.

There are several reasons for using silicon in manufacturing rectifiers. The new silicon rectifiers do not age and, therefore, will give a continuous high *dc* voltage over an extended period of time. They have considerably lower forward drop than selenium or vacuum tube rectifiers, giving higher *dc* voltage output in the same rectifier circuits. They are hermetically sealed and not subject to corrosion. They can operate at elevated temperatures and, therefore, may be placed in any part of a conventional TV or radio circuit without harm to the rectifiers. They are very compact and with their pig-tail leads may be wired directly into a circuit in much the same way as a resistor or capacitor. Finally, in replacing selenium rectifiers with silicon units, it is not necessary to remove the old unit, but simply to clip the leads.

On those sets currently using selenium rectifiers, it is possible to replace the selenium rectifier with a silicon

rectifier during a normal service repair call. This replacement is very simple since it is not necessary to mount the silicon rectifier in a particular manner, and it may be wired directly into the circuit after clipping the selenium rectifier out. A word of caution—do not at any time place the silicon unit in parallel with the selenium unit since their characteristics may not match sufficiently to allow parallel operation.

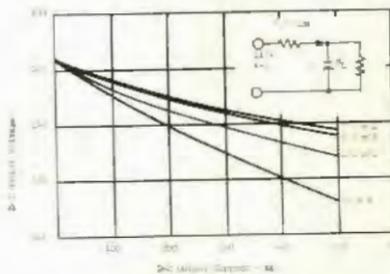
The regulation characteristics of the 1N1169 in typical rectifier circuits found in radio and T.V.

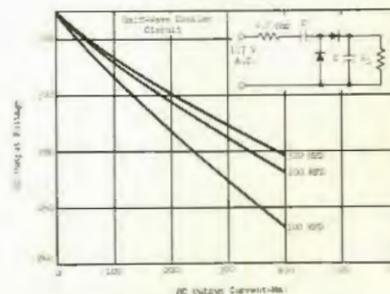
Operation characteristics of the 1N1169 in voltage doubler circuits commonly found in T.V.

Also, the silicon units may be used in voltage doubler circuits commonly found in TV sets by replacing each selenium unit with a silicon unit.

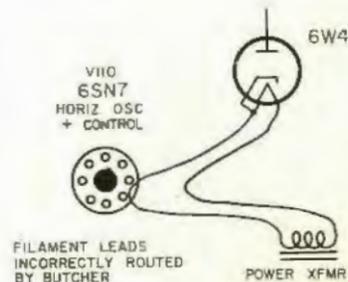
Fig. 1—The damper filament leads upset oscillator sync.

The customer stated that a friend of the family had installed a power transformer and since that time the receiver had a critical horizontal sync condition. The receiver was turned on and it was observed that the receiver indeed had a critical horizontal sync condition. The power transformer circuitry was next examined and was found to be wired correctly. As a "sure" check the following tubes were replaced: V107, 12AU7, dc restorer and sync amplifier, 6SN7, V108, sync amplifier and V110, 6SN7 horizontal oscillator and control. These were all replaced individually, but had no effect. Voltage checks were next made at the horizontal oscillator and control tube V110, 6SN7. It was noted here that as we moved wires around in the oscillator circuit, the picture would lock in and move out of horizontal sync. Here was the clue! With an insulated alignment tool, wires in this circuit were moved around to determine which had the greatest effect. It was discovered that when the filament wires of the 6W4 damper were moved, the greatest effect on the horizontal sync occurred. These filament wires were passing directly over the horizontal oscillator V110 as shown in Fig. 1. We remembered that

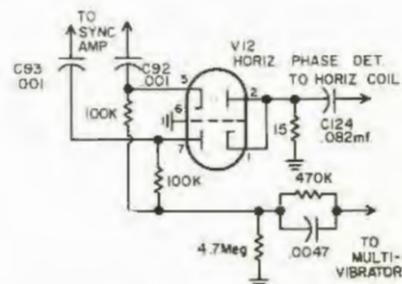
Fig. 1—Partial schematic of the horizontal *afc* system used in the Spartan 15V215 TV set.

In examining the schematic of the receiver, one component seems more likely to be the cause of the problem than the others. This component is condenser C124, a .082 mf condenser as shown in Fig. 1. The condenser is very likely developing an increasing amount of leakage as it becomes warmer in the cabinet. On the service bench this might be simulated by holding a heavy soldering iron or gun near the condenser so that heat can be radiated into the condenser. Of course, the heat could be applied with a heat lamp but this causes all the components to become warm and doesn't indicate which one is at fault. If condenser C124 develops a leak it will cause a positive voltage to appear at the grid of the multivibrator. This voltage check will indicate that the condenser is leaking. In replacing it, use a condenser with a voltage rating of 600 volts.

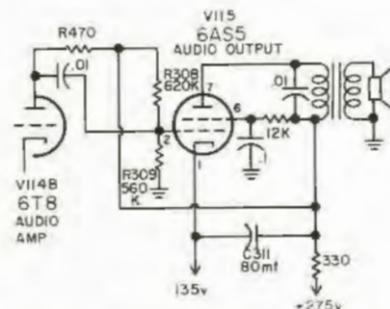
Fig. 2—Audio output stage of the GE ST line. Defect in R308 or R309 could cause distortion.

The fact that the audio is slightly distorted may be the clue to the whole situation. In examining the circuitry it will be found that the audio output tube performs the additional function of voltage division. The resultant voltage obtained at the 6AS5 audio output cathode of 135 volts is fed to the 6BY6 sync clipper tube as well as other stages in the receiver. An increase in the voltage from the cathode of the audio output tube will adversely affect the sync clipping operation. It may even affect the video *if* amplification if the 135 volts has increased appreciably. There would most probably be an accumulative effect on the problem in that the video level from the *if* stages would be greater than it should be, thereby increasing the sync separation problem.

The cause of an increase of the 135 volts from the audio output tube may be a result of a number of possible causes. First, strange as it may sound, the 6AS5 audio output tube should be replaced. The tube itself may be at fault.

There is one other possibility that should also be investigated should the trouble still remain elusive. This possibility is condenser C311, 80 mf. Should the condenser have developed leakage the 135 volt potential will be increased and thus account for the existing symptoms.

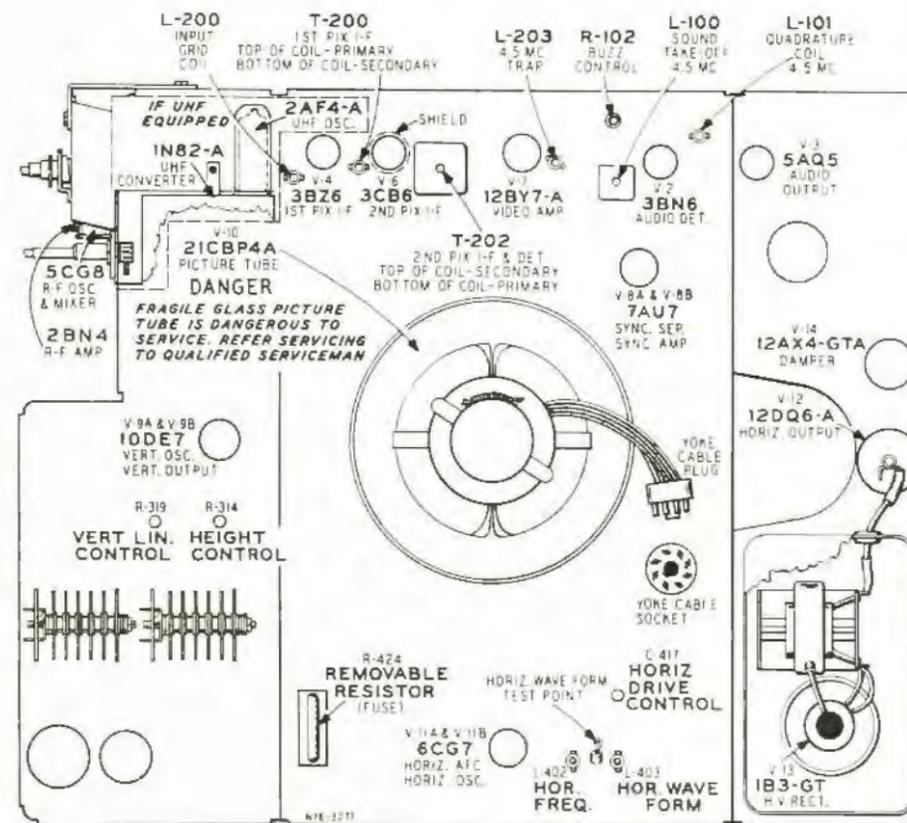
Chassis Tube Layout and Trimmers

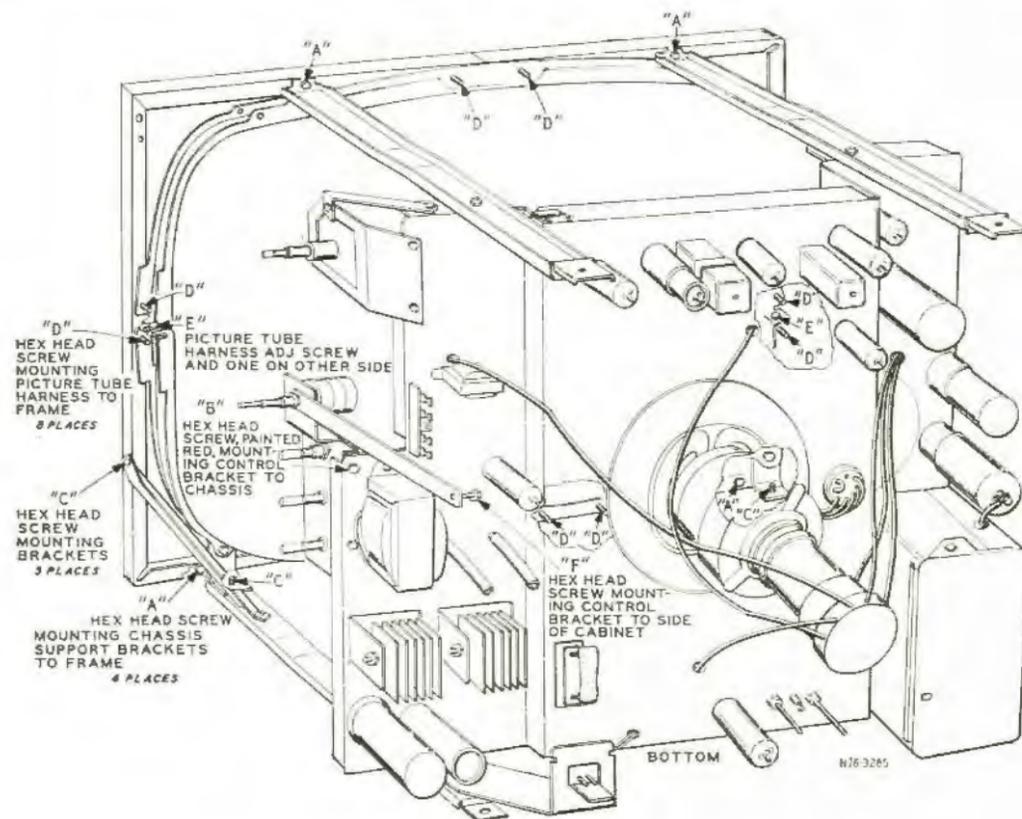
Picture Tube Replacement

1. Remove 4 screws marked "A" on illustration.
2. Remove 2 screws marked "B" on illustration.
3. Remove 3 screws marked "C" on illustration and lift chassis from Pix Tube Frame Assembly.
4. Loosen 8 screws marked "D" and 2 screws marked "E" on illustration.
5. Remove old picture tube and install new tube reversing the steps outlined above, keeping the following in mind:

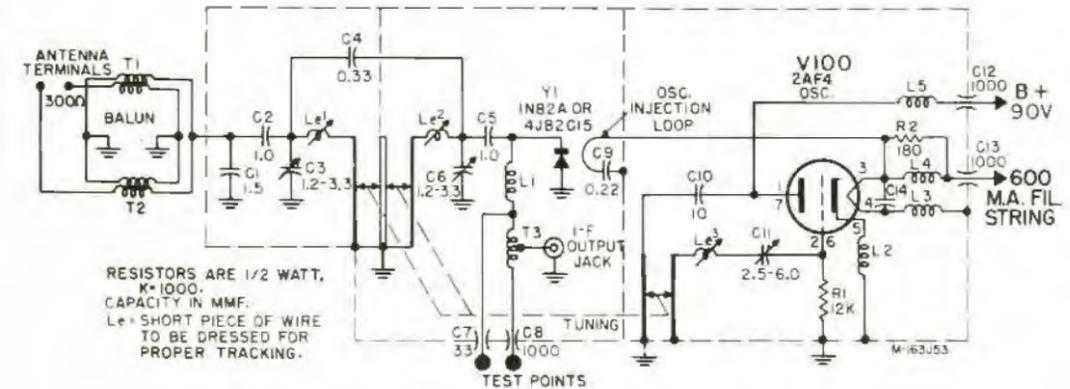
Schematic Diagram for UHF Tuner, RUX-023

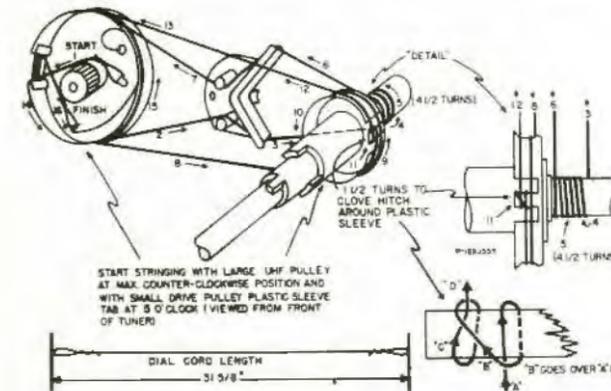
UHF Tuner Drive Stringing Diagram

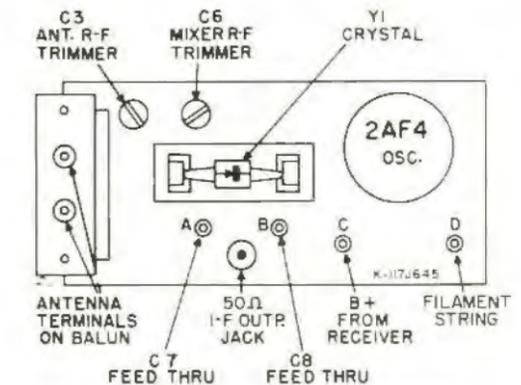
Top View UHF Tuner RUX-023

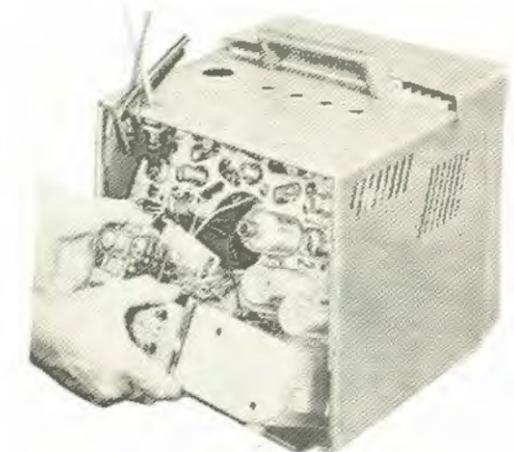
Chassis Removal

To install the chassis, reverse the above procedure, making sure that the anode and speaker leads are connected and the phosphor bronze terminal which is soldered to the by-pass condenser on the tuner is inserted in the bottom of the nylon nut so that the bottom screw secures the terminal to the bottom of the cabinet.

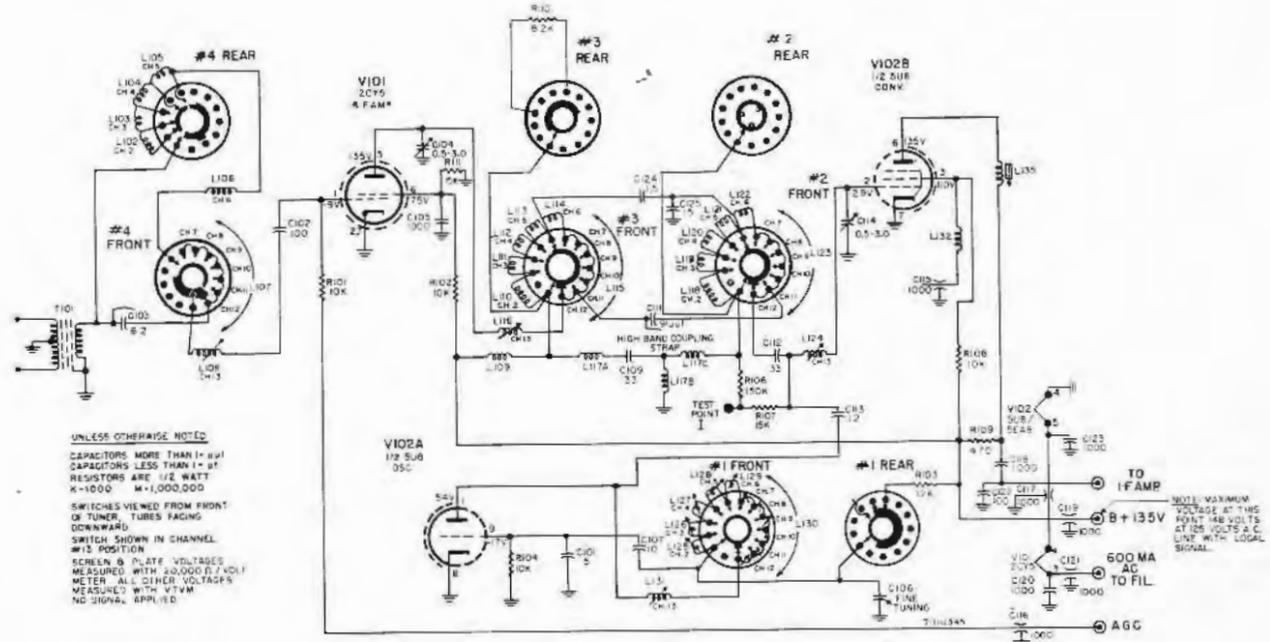
Schematic Diagram VHF Tuner RJX-099

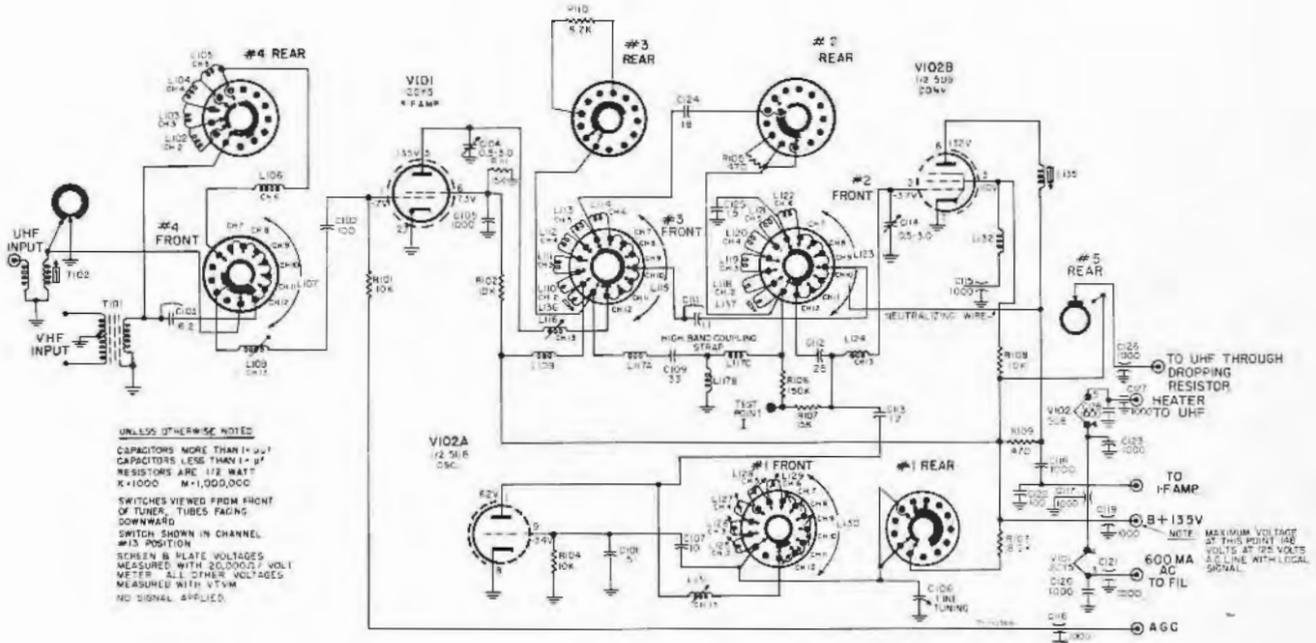
Schematic Diagram VHF Tuner RJX-100

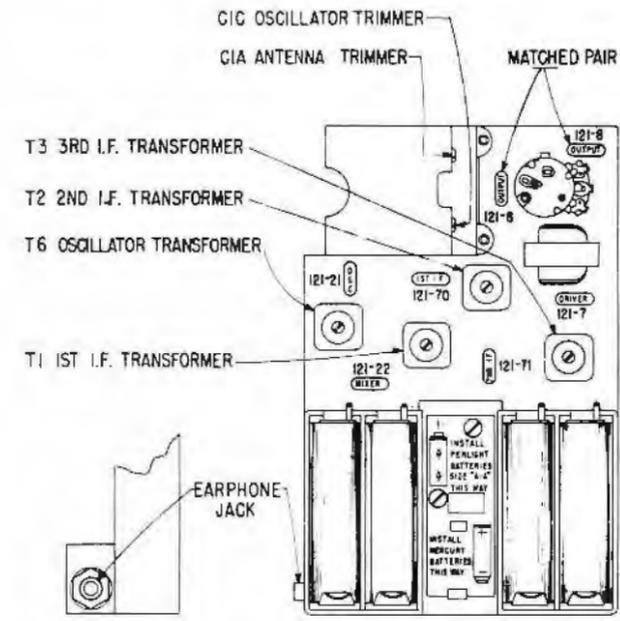
TRANSISTOR & TRIMMER LAYOUT FOR 7AT42

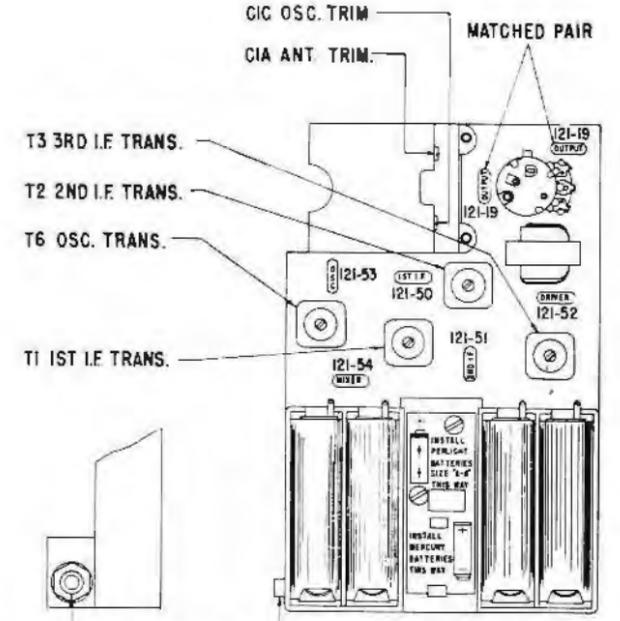
TRANSISTOR & TRIMMER LAYOUT FOR 7AT42Z1

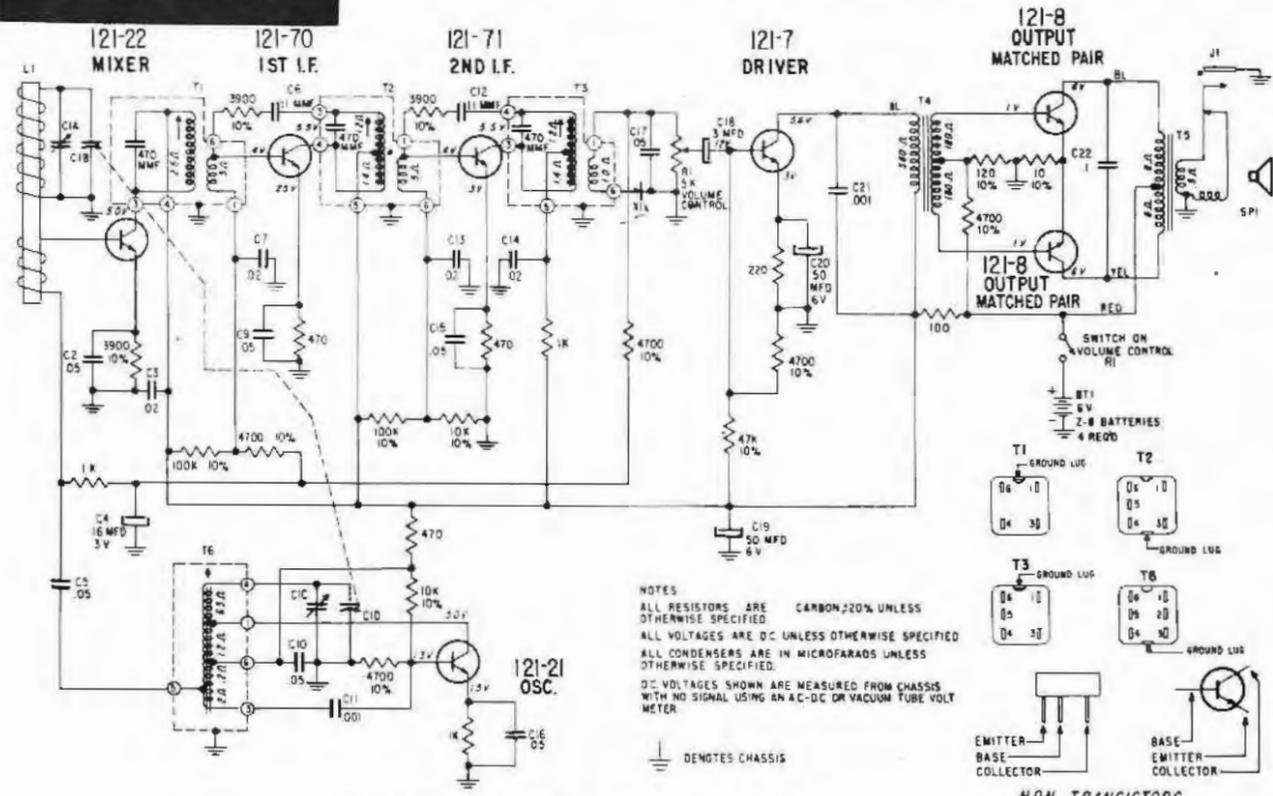
Schematic Diagram for 7A T42

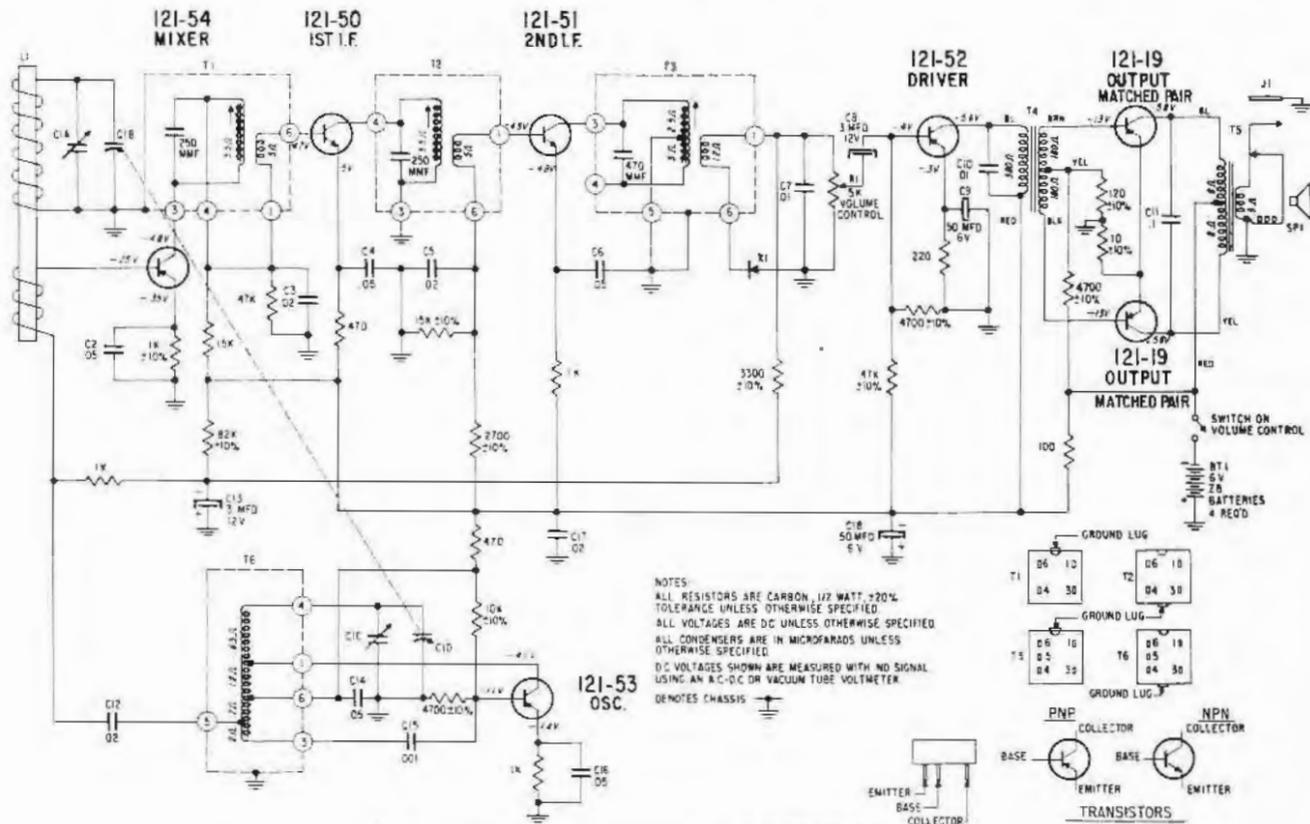
Schematic Diagram for 7A T42Z1

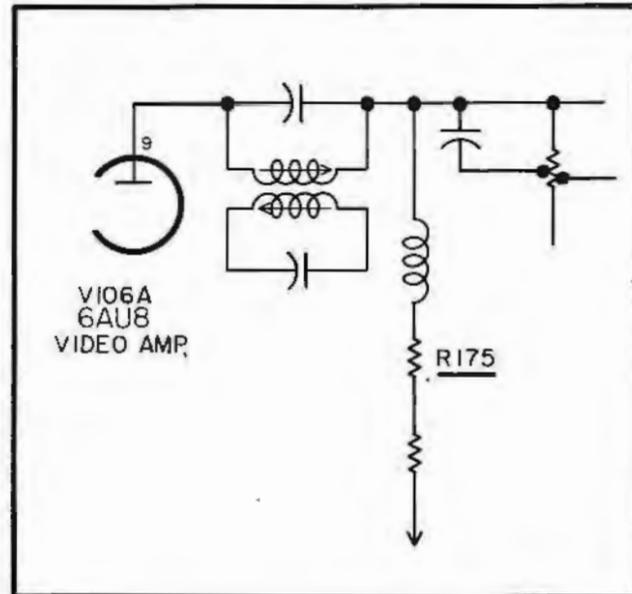
Mfr: General Electric Chassis No. U  
 Card No: GE-U-4  
 Section Affected: Pix  
 Symptoms: Negative pix.  
 Cause: R175 video plate load resistor open. B plus is still fed thru R173.  
 What To Do: Replace R175, 5600 ohm 2W.

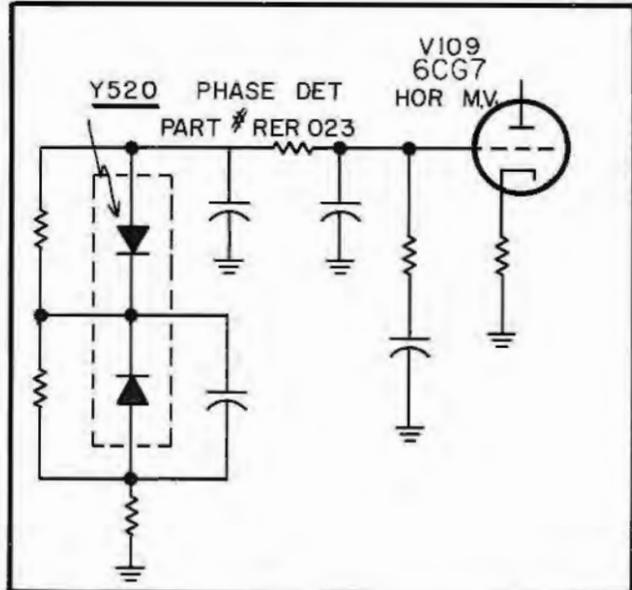
Mfr: General Electric Chassis No. U  
 Card No: GE-U-5  
 Section Affected: Raster and sync.  
 Symptoms: Intermittent loss of raster and horizontal sync.  
 Cause: Open, leaky or mismatched dual seleniums.  
 What To Do: Replace seleniums Y250 with part number RER-023. If not available a matched pair of germaniums will be satisfactory.

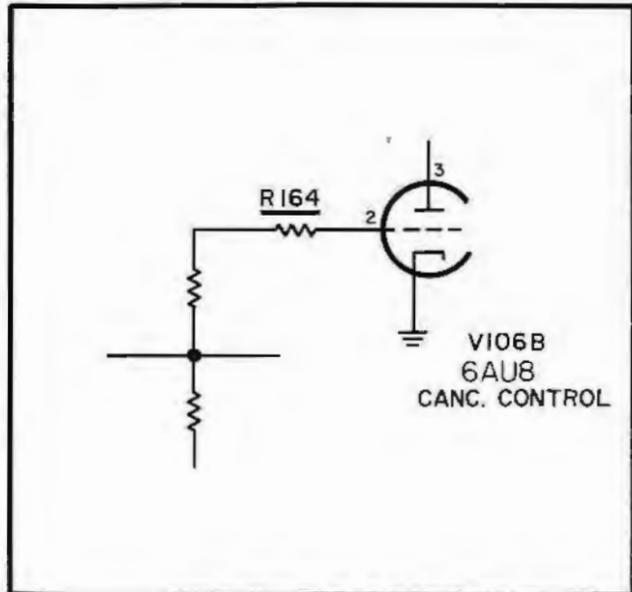
Mfr: General Electric Chassis No. U  
 Card No: GE-U-6  
 Section Affected: Pix  
 Symptoms: Intermittent overload and poor signal to noise ratio.  
 Cause: Gassy 6CF6 tubes in the first and second if stages.  
 What To Do: The circuit can be modified simply so that gassy tubes do not upset proper operation. Change R164 from 2.2 megs to 100K.

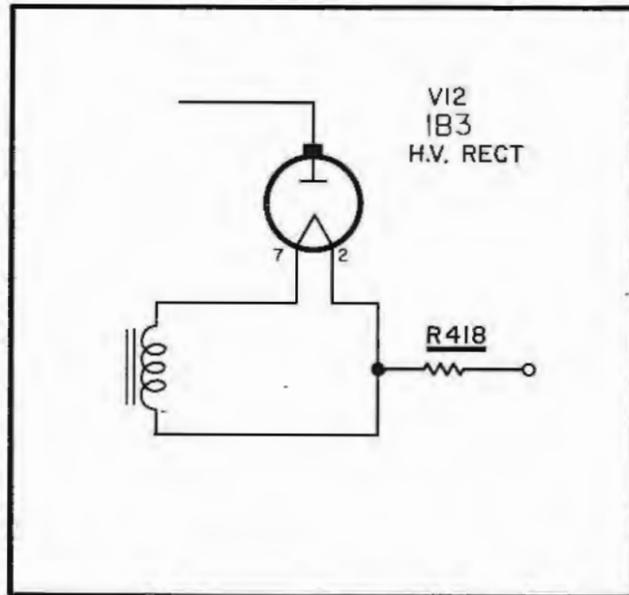
Mfr: Sylvania Chassis No. 1-537  
 Card No: SY-1537-4  
 Section Affected: Raster  
 Symptoms: Streaks in raster.  
 Cause: R418 is arcing internally.  
 What To Do: Replace R418, 4700 ohms.

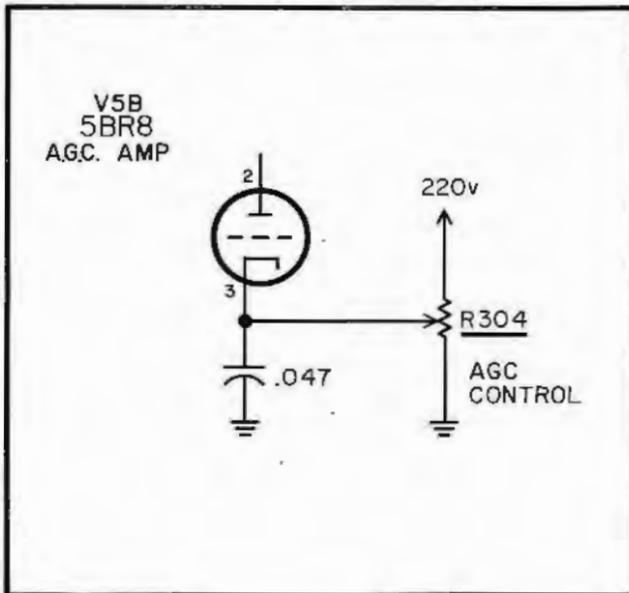
Mfr: Sylvania Chassis No. 1-537  
 Card No: SY-1537-5  
 Section Affected: Pix  
 Symptoms: Video overload.  
 Cause: R304, agc control is open.  
 What To Do: Replace R304, 150K control.

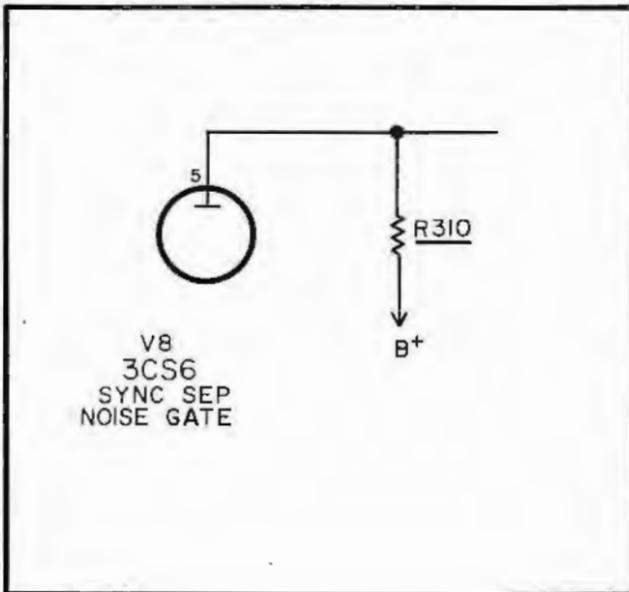
Mfr: Sylvania Chassis No. 1-537  
 Card No: SY-1537-6  
 Section Affected: Sync.  
 Symptoms: Horizontal tearing and intermittent vertical roll.  
 Cause: R310 has decreased in value.  
 What To Do: Replace R310, 220K.

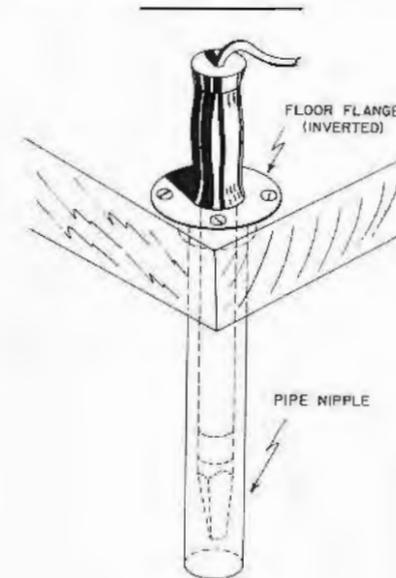
Store a hot soldering iron safely out of the way, but handy for use, by dropping it into a pipe nipple set in the workbench. Fit the neck of a floor flange in a hole in the bench; mount the flange upside down, then, from beneath the bench, turn a pipe nipple into the threaded flange.
