SERVICING-VIDEO-CONSTRUCTION-COLOUR-DEVELOPMENTS TELEVISION JULY 1976 OPTOCOUPLED AUDIO EXCRACTOR

PATCHING PCBs THORN 1500 CHASSIS MORE ABOUT TV ICs TELEFUNKEN 711 CHASS SOLID STATE FIELD OSCIL ATORS

SERVICING VIDEO CONSTRUCTION COLOUR DEVELOPMENTS

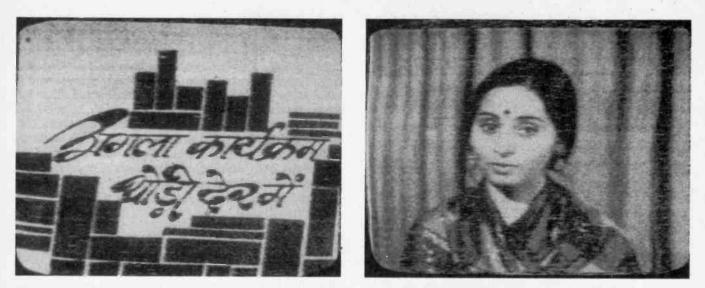
The pictures above show the greatly improved quality of reception from the ATS-6 satellite now being achieved by Steve Birkill.
