Adding Raster Correction to the Thorn 2000 Chassis 522 by Keith Cummins The Thorn 2000 was the world's first solid-state colour chassis - but didn't have raster correction. Many of these sets are still in use so Keith Cummins decided to see how this deficiency could be rectified.

530	Diagnostic Pattern Generator Circuit, description and component details for latest project which provides four diagnostic plus a teletext simulation feature to enable r performance under various conditions to be	or this patterns receiver	y Malcolm	Burrell
E 2 4	TV Sonvicing : Beginners Start Here	Part 11	hu C	Simon

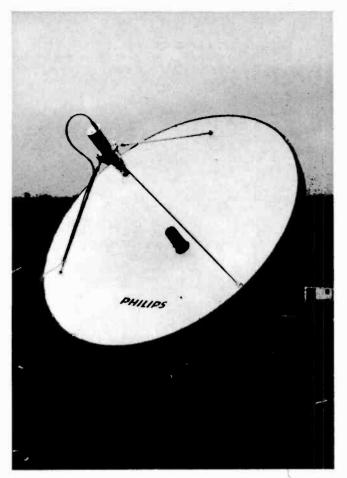
Philips 1.2m dish/head end used for the Canadian CTS satellite experiments.
