AUDIO ALIGNMENT PROCEDURE

VOL. 1, NO. 1

TC CHASSIS -- POWER SUPPLY PRE-REGULATOR TRANSISTOR (Q21) FAILURE

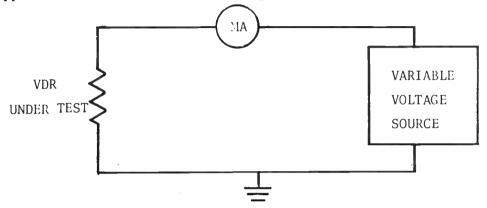
Figure 1 - VDR Test Circuit

Most VDR's will read open when checked with a simple ohmmeter. Therefore, the VDR must be tested by applying a voltage to it and measuring the current through it. Such a test may be done with the VDR in the TV circuit or in a special bench test circuit. In either case, a milliammeter is placed in series with the VDR, and the voltage applied to it is varied. (See Figure 1.)

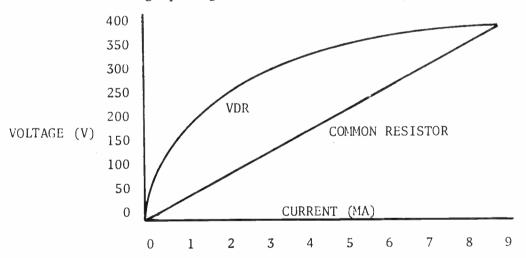
Figure 2 - Voltage vs. Current for a negative coefficient VDR

Plotting a graph of voltage vs. current for the VDR shows its performance characteristics. Such a graph might look like that in Figure 2.

VDR's come with many voltage and current ratings, so don't expect the values in Figure 2 to exactly agree with the numbers on your graph. The important thing is for the non-linearity of current change with voltage variations to be evident.

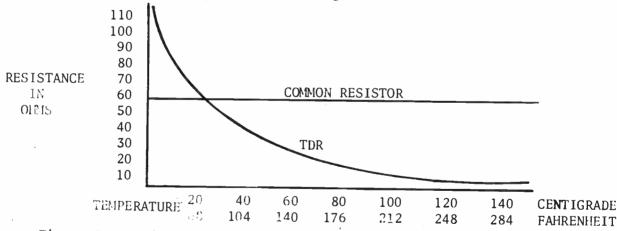
Figure 3 - Resistance vs. Temperature for a TDR and a common resistor.

The TDR is a non-linear resistor whose resistance is a function of temperature. The heat that influences the TDR can be externally applied or developed by the current passing through the device. Characteristics of a typical negative coefficient TDR are compared with an ordinary resistor in Figure 3.

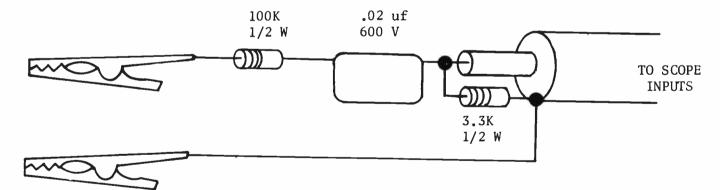
A suitable input cable network is shown below. Construct two identical cables, placing the resistors and capacitors near the clip, as shown.

To calibrate the scope, connect the cables to the scope input terminals. Apply a 30 volt RMS signal to the vertical input cable, and adjust the scope vertical gain controls for a 2-inch vertical line. Disconnect the vertical cable. Then apply the 30 volt RMS signal to the horizontal input cable, and adjust the scope horizontal gain controls for a 2-inch horizontal line. Disconnect the 30 volt RMS source. Do not readjust the gain controls after this calibration.

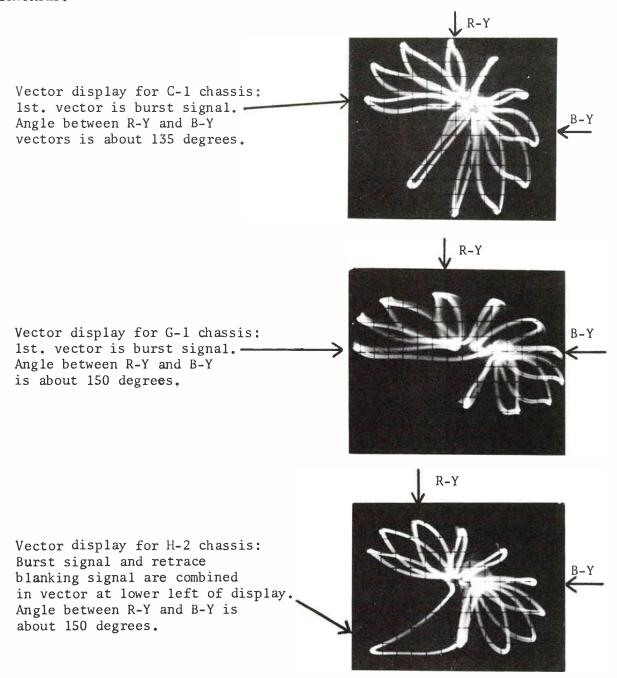
Normal scope displays for various chassis are shown below. Adjust the receiver's COLOR control to vary the size of the scope display. DO NOT ADJUST THE SCOPE GAIN CONTROLS.

If the vector display appears to be inverted, check the Vertical Polarity Switch on the scope (positive voltage should cause upward deflection) and the input cable connections (R-Y signal to vertical input and B-Y signal to horizontal input).

The vectors should be properly positioned when the TINT control is at, or near, the center of its range. Rotating the TINT control through its range should cause the vectors to shift at least 40 degrees each way.
