OVER THE SOLDERING IRON

RCA VICTOR

PREPARED FOR THE INFORMATION OF RCA
VICTOR DISTRIBUTORS' SERVICE MANAGERS

SERVICE DIVISION - RCA MANUFACTURING CO., INC. - CAMDEN, N. J. - JULY 15, 1938

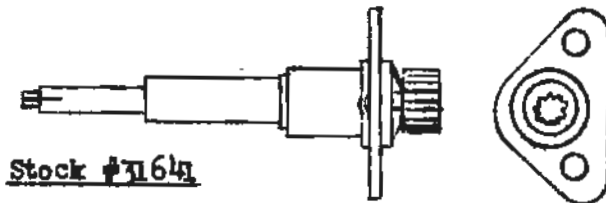
Stock #11641

Three types of vernier drives were employed on tuning condensers of the 6 - 10 tube receivers. These drives are not interchangeable and it is therefore essential, where replacement is required, to order the correct part. Identification may be established by comparison with the illustrations, which are shown to scale, at the left. These drives are used on the following models:

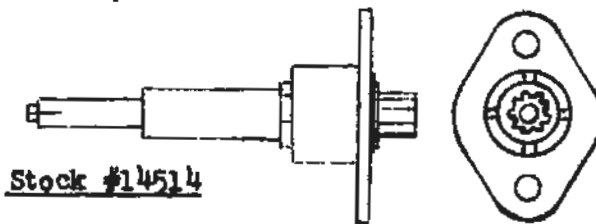
Note that Stock #14514 supersedes Stock #14364.

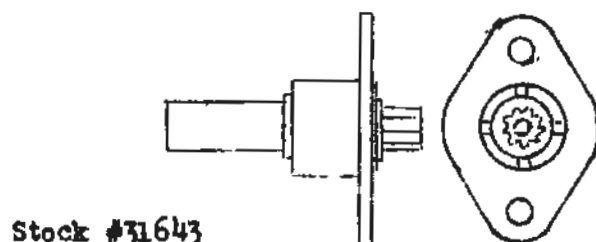
Stock #11643

Two types of vernier drives are to be found on Models 87K1, 87T2, 87K2 and U-106. When ordering replacements, the correct part may be identified by comparison with the two diagrams to the left. These are drawn actual size.
