AND HOME ELECTRONICS REPAIR

MARCH 2004 £3.20

Servicing the Philips LO1 chassis Simple volume compressor circuit

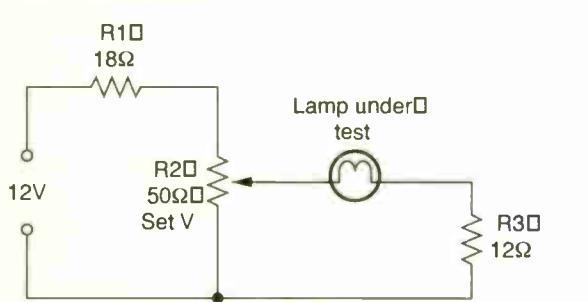
Table 1	: Lamp chara	acteristics	
Lamp V	V across R3	Lamp I (mA)	Lamp R (Ω)
0.25 0.5 1 1.5 2 2.5 3 3.5	0.85 1.09 1.47 1.8 2.1 2.36 2.62 2.85	71 91 122 150 175 197 218 237	3.52 5.49 8.19 10 11.42 12.7 13.76 14.77

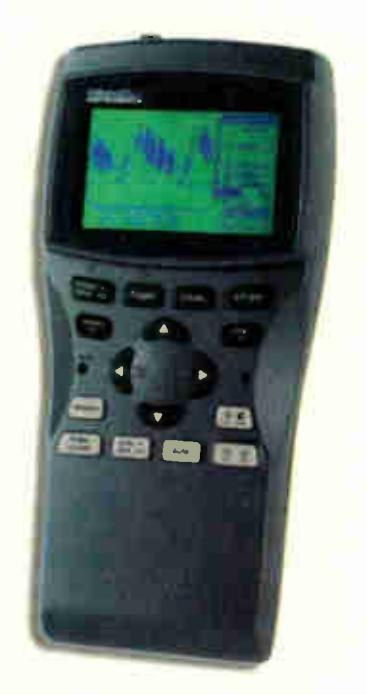
The Velleman HPS40 hand-held scope

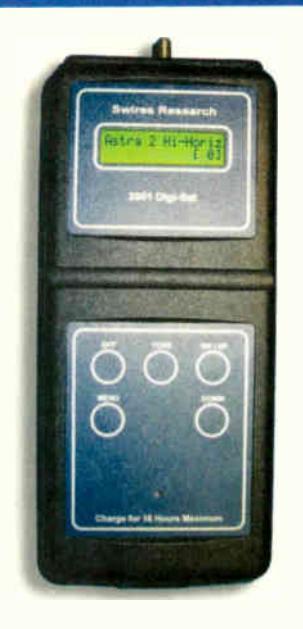
The Swires Research Digi-Sat 2001 reception tester

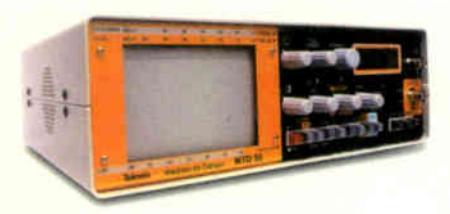
The Televes on-screen indicating Model MTD50.

Right: A simple, inexpensive satellite signalstrength meter from Televes While the need for convergence-adjustment crosshatch generators has fallen off, it is quite the reverse with reception testers. The terrestrial and satellite bands have become busier and more crowded with transmissions, digital and analogue, and optimising reception is now an exacting business. This is especially true of terrestrial digital broadcasting, where the early (pre-broadcast) promises of rugged transmission and reliable reception have proved to be false and concepts like 'graceful degradation', in which picture quality is related to bit-error rates, have been discarded. Hence the need for instruments that show not only the signal strength but also identify the programme source and indicate quantitatively its received goodness - in terms of bit-error rate and carrier-to-noise ratio. There are now several of these precise and complex instruments to choose from, but not at the price of the old "wow: stop now" meters. We'll consider first those designed for terrestrial DTV use: in the UK this currently means Freeview reception.

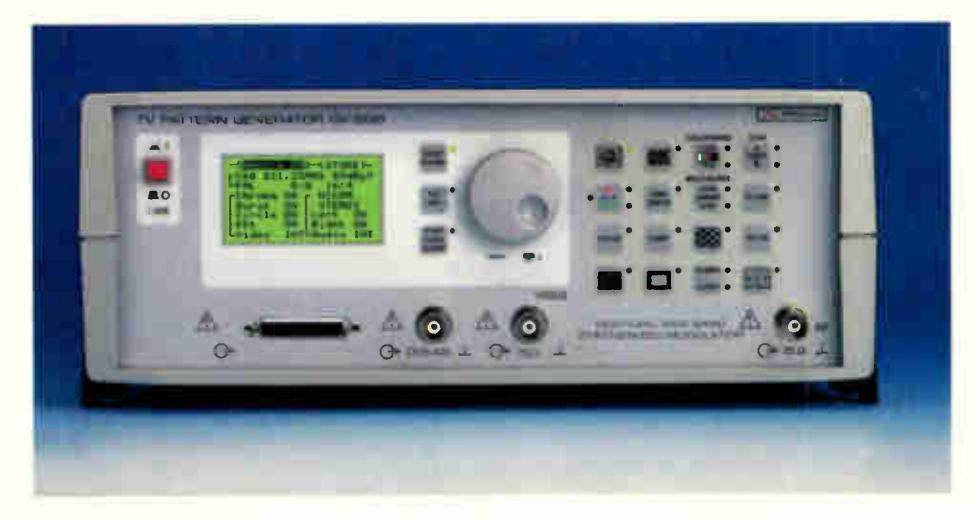
Top: The Promax GV998 MPEG-2 DTV pattern generator.

There's less need for convergence and purity setting now, but a pattern generator is still very useful, especially after replacement of data-memory chips and components in CRT-scanning circuitry.

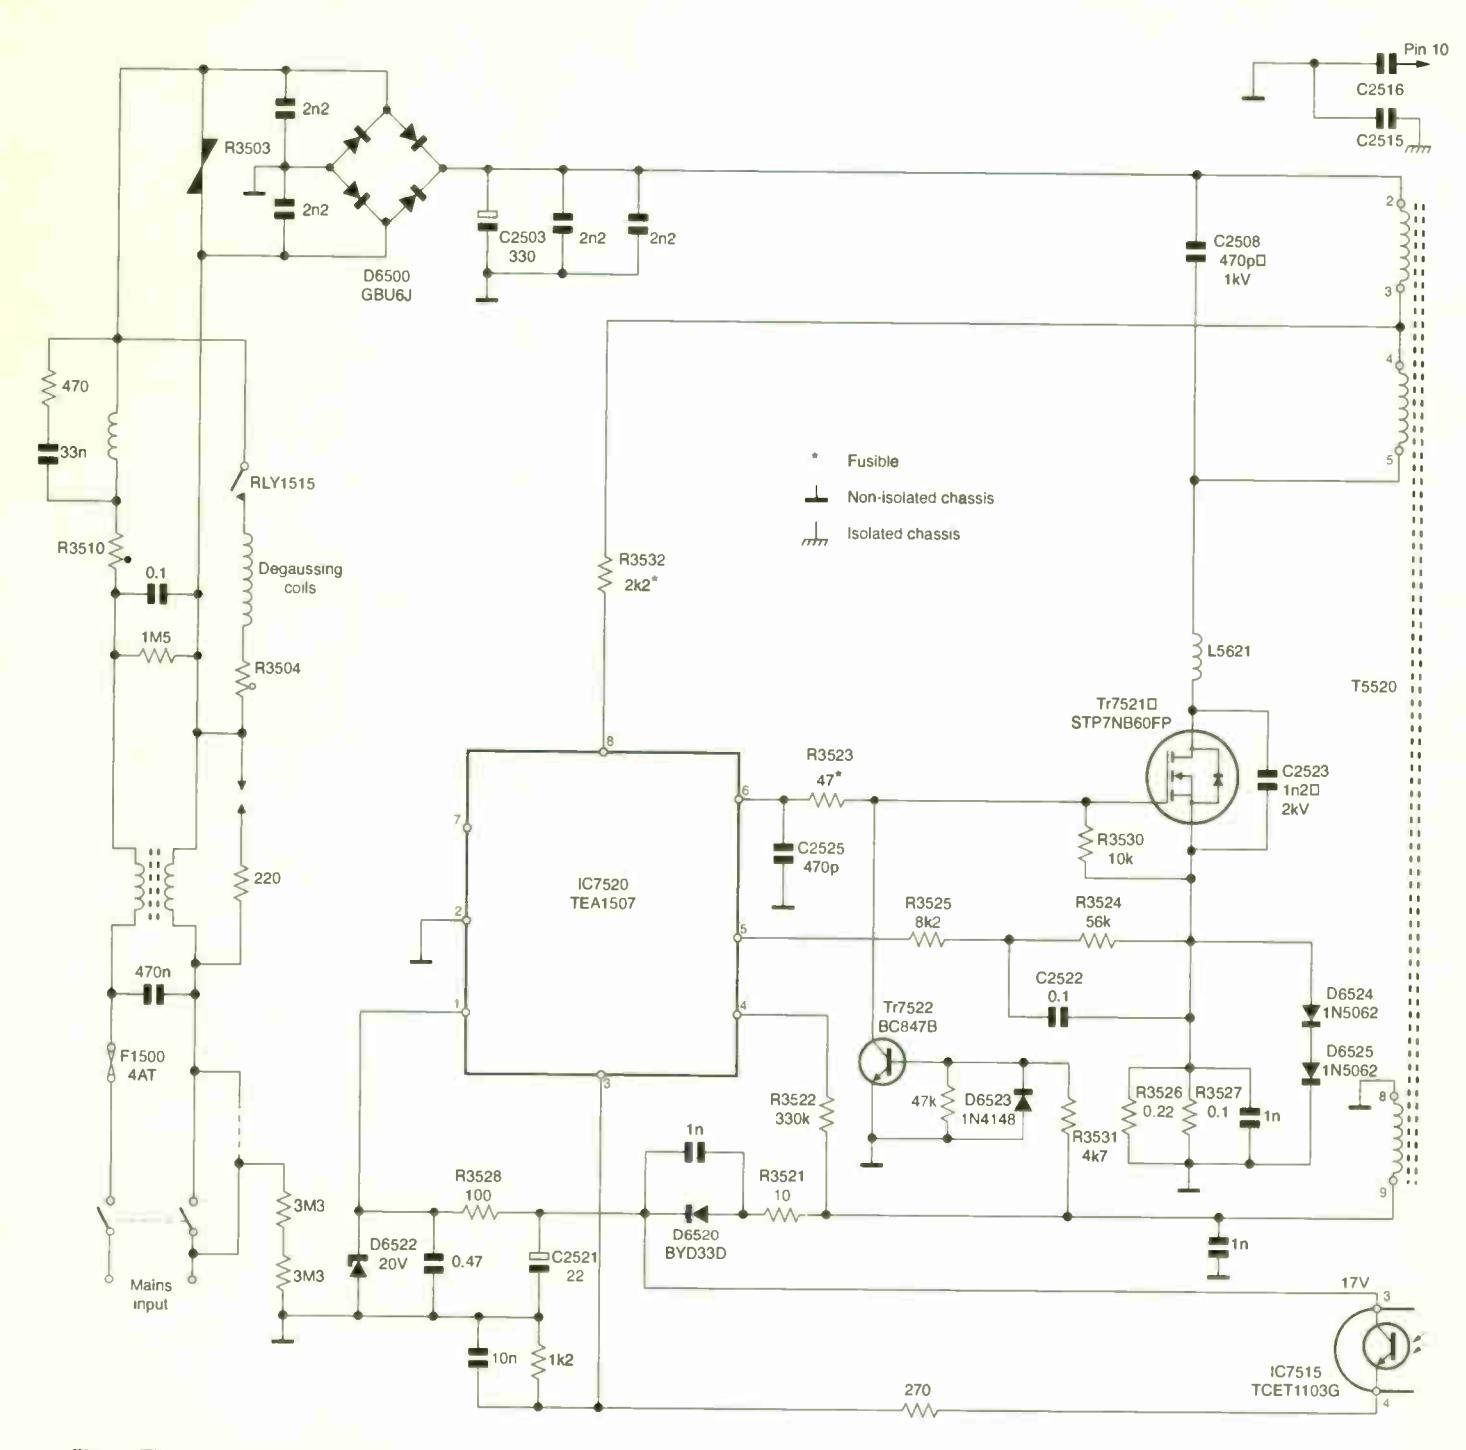
Fig. 1: The circuitry on the primary side of the chopper power supply.

The chopper power supply, see Figs. 1 and 2, is based on the popular TEA1507 control chip (IC7520), a so-called second-generation green chip. This 8-pin dual in-line IC is designed to maximise power efficiency in all operating modes. A special feature, called the burst mode, can be used for low-power standby operation. In this mode the chip produces controlled bursts of switching signals to operate the chopper power supply in a low-power condition, producing just enough power to maintain the 3·3V supply for the UOC device.

Transistors Tr7541 and Tr7542 are used for standby switching. When a standby command is received the UOC activates this circuit. IC7520 detects the condition, which it interprets as a drastic overload, switching to the burst mode for safe operation.

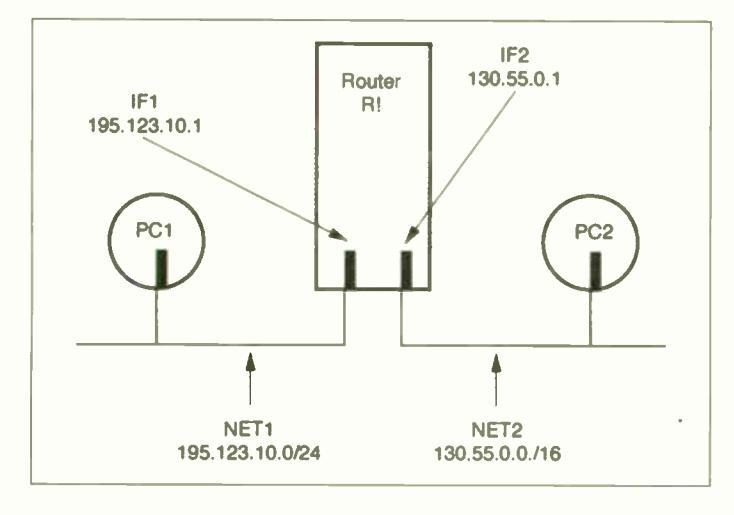
Fig. 1: A router with two interfaces connected to two networks.

The first entry in the table states that for network 130.55.0.0, subnet mask 255.255.0.0, the router (normally know as the gateway) has an IP address of 130.55.0.1, i.e. IF2. The second entry states that for network 195.123.10.0, subnet mask 255.255.255.0, the gateway has an address of 195.123.10.1, i.e. IF1. Thus messages, in the form of frames, arriving at IF1 destined for network 130.55.0.0 are directed to IF2; conversely messages arriving at
