SEPTEMBER 1960

**RADIO**  
Retailing

# SERVICE ENGINEER

Radio, Television and Audio Servicing

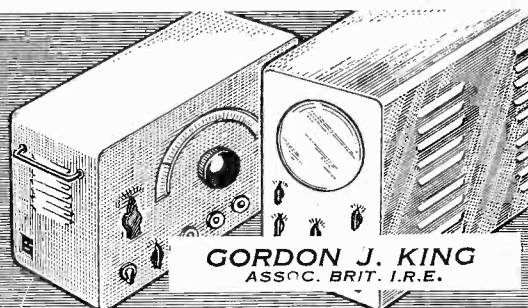
# Modern Test Instruments

**I**N addition to the signal generator, which was dealt with last month, life is made much easier for the practicing service technician if he has available, for immediate action, a generator for producing a locked pattern on the screen of a television receiver.

With such a device of known signal characteristics and level an after-service television receiver can be made ready for delivery to its owner without the aid of a BBC or ITA transmission. Height, width, linearity, picture shift, focus and other adjustments are thus facilitated, and once one is really conversant with such an instrument, a receiver so set up in the workshop will be a sure bet for working on the customer's aerial with only the smallest of final adjustment. This can save time and relieve more skilled staff for the jobs better suited to their qualifications.

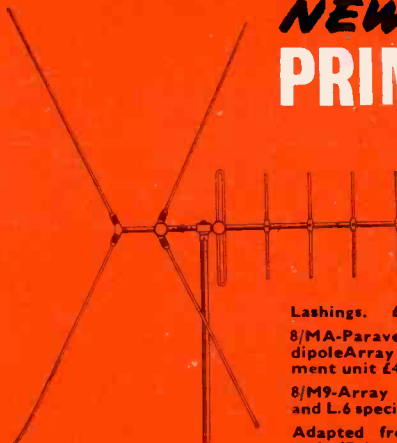
## NEW PRIMAX

Adapted from the popular and efficient Paravex, primax 5 and 8 element combined Array, factory matched and wired—no filter box needed—for semi fringe areas. Available with or without the boom swivel for separate band orientation, Primax feature the new "Finger Fix" folding Insulator and spring loaded I.T.A. elements for fast fitting, and with the usual sturdy Telerection materials and construction unchanged—prices are down to earth—giving Rental Concerns the ideal Aerial—well built, of top grade alloys, high performance, rapid assembly and inexpensive.
